Sustainable bed-joint-reinforcement
system revamps stability and
aesthetics of Miami's Olympia Theatre

In Concert With Restoration

Sustainable bed-joint-reinforcement system revamps stability and aesthetics of Miami's Olympia Theatre

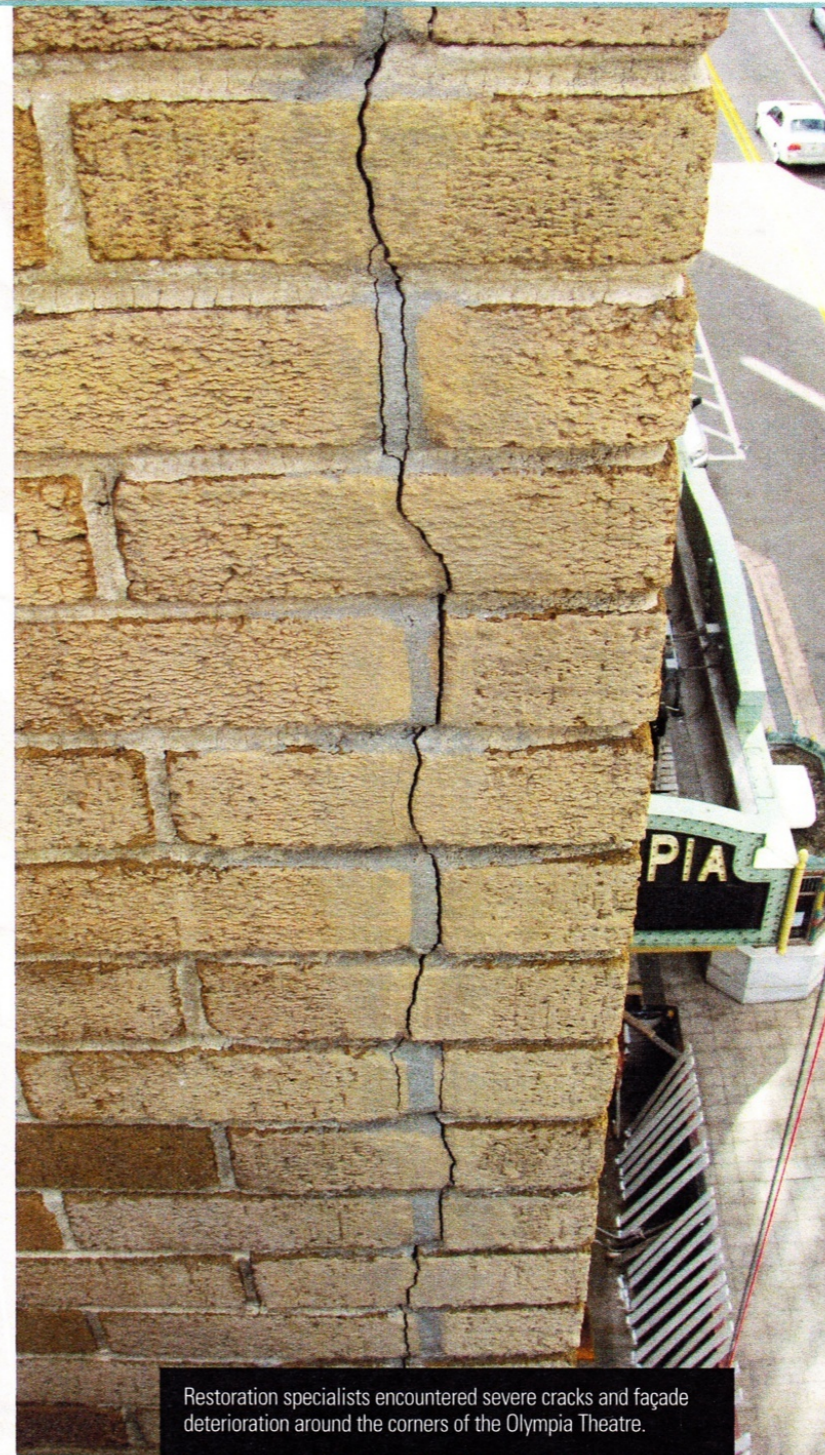
Restoration specialists encountered severe cracks and façade deterioration around the corners of the Olympia Theatre.

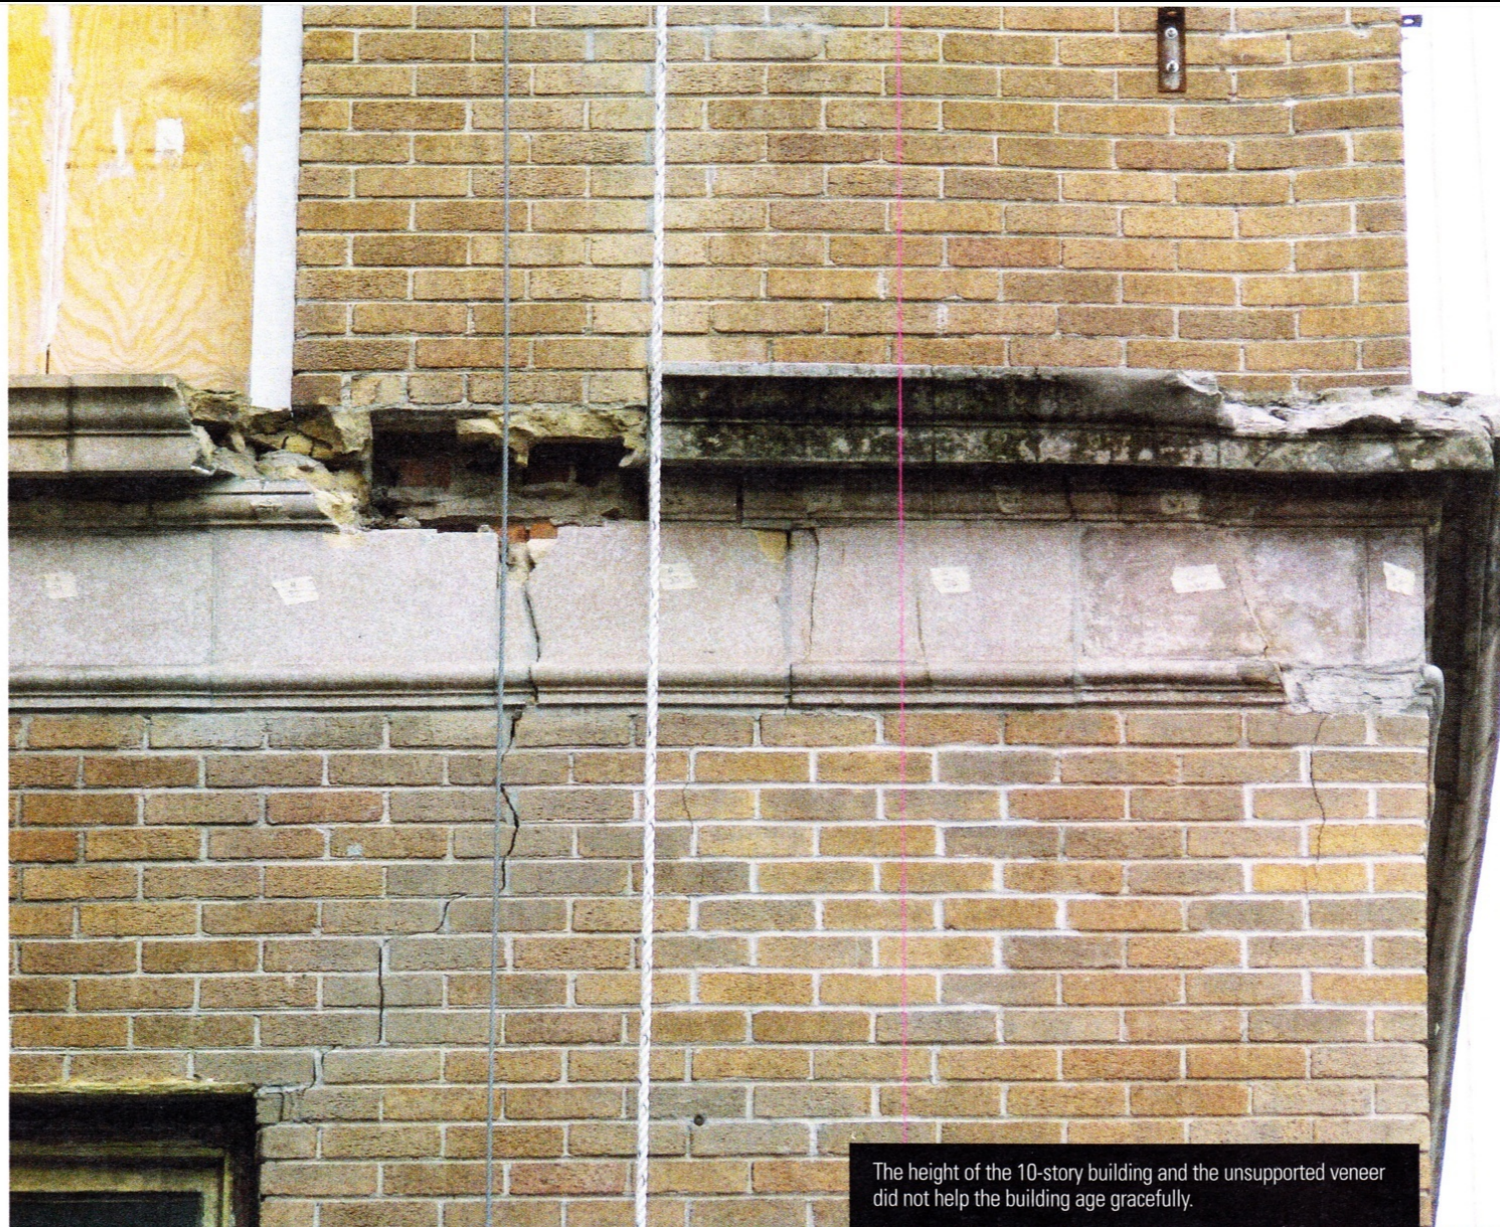
The height of the 10-story building and the unsupported veneer did not help the building age gracefully.

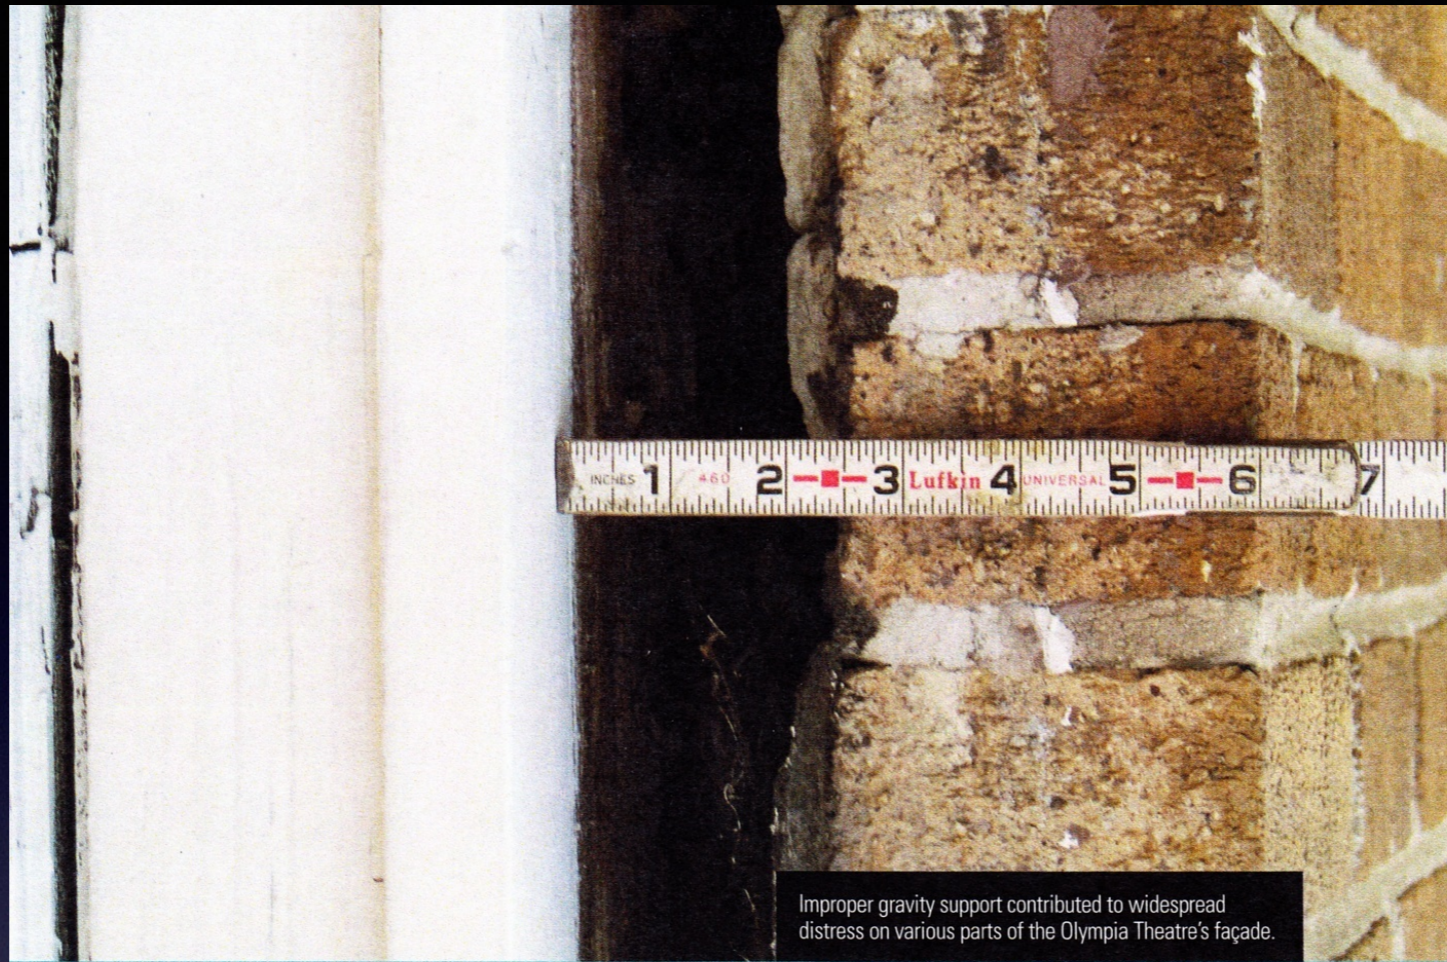
- Widespread distress due to improper gravity support
- Diagonal brick cracking originating from the lintel ends
- Compressive failures within the second- and third-floor terra cotta water tables
- Delaminated faces of the water-table projecting elements
- Bowed displacement of the veneer in excess of 2 inches.

Improper gravity support contributed to widespread distress on various parts of the Olympia Theatre's façade.

Crews laid two horizontal rows of 7-meter-long stainless-steel HeliBars in tandem at various levels around the entire circumference of the building.

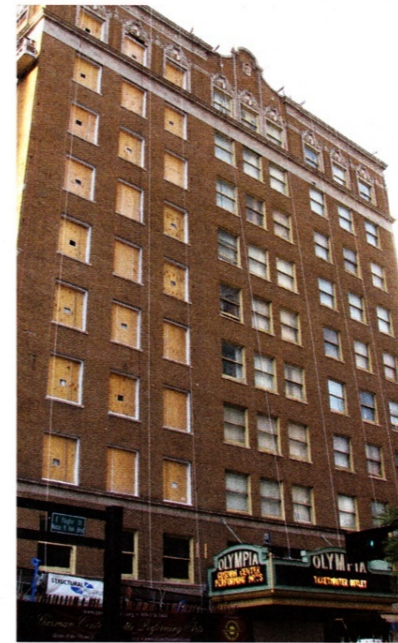
Sections of the Olympic Theater (Miami) were taken down and rebuilt to address structural and safety issues.

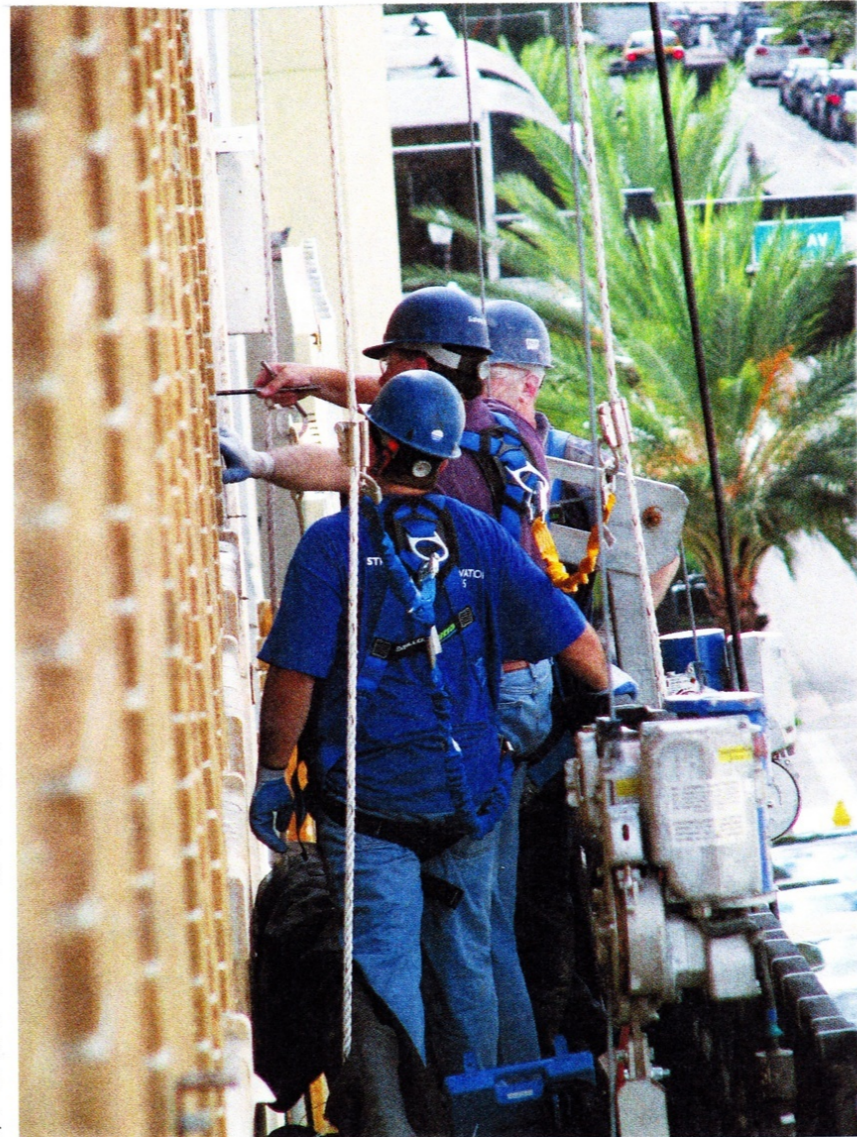
WJE collaborated with Helifix
to provide a lateral
and gravity support system.

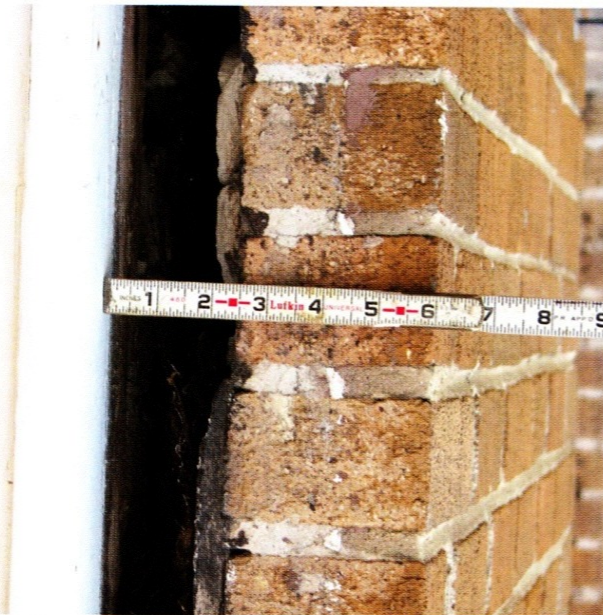
Displacement of veneer in excess of two inches.

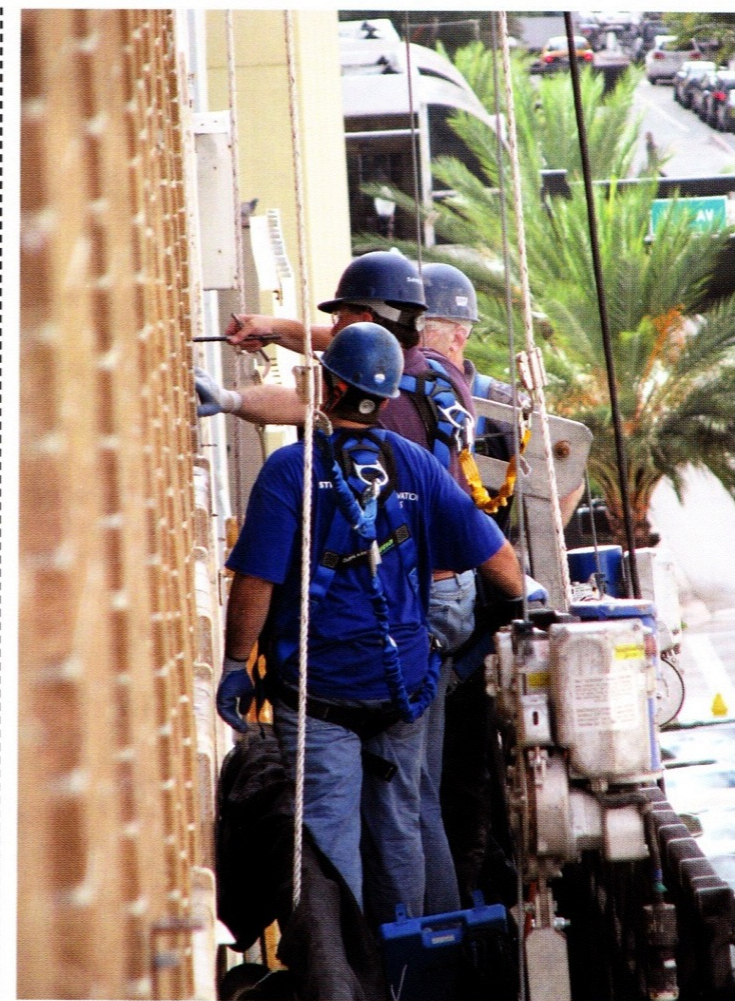
Helifix on-site quality control support team and STRUCTURAL'S specialty repair contractors perform installation.

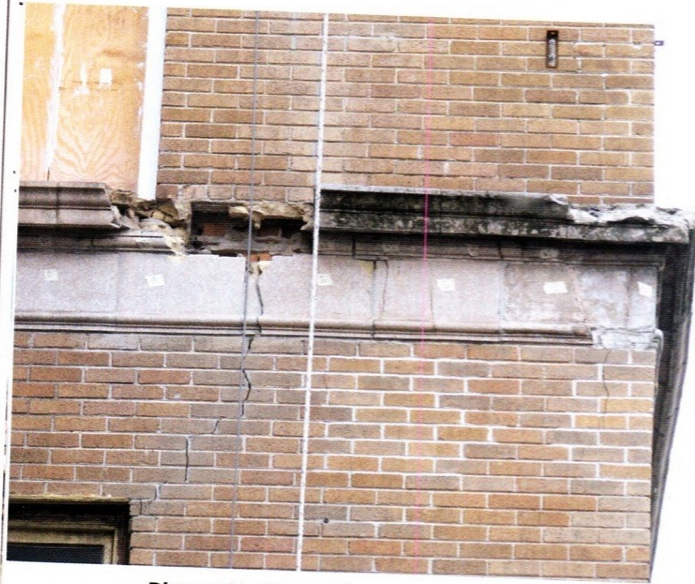
Diagonal brick cracking originating from the lintel ends.

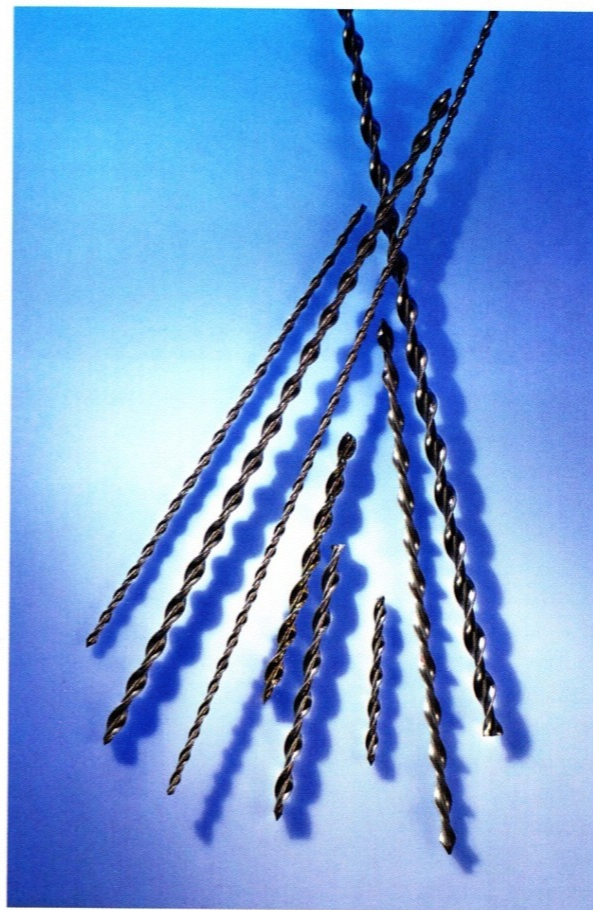
Helifix's Helibeam System HeliBars create reinforced "beams" across each spandrel level.

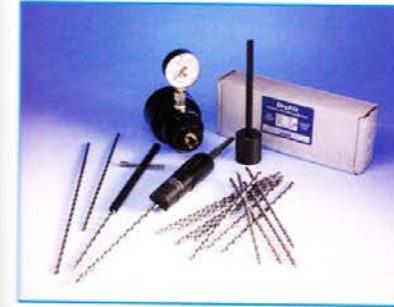
DRYFIX

About 6,400 DryFix helical anchor ties were used throughout key focus areas of the tobacco warehouse's north, south and west elevations. Also, roughly 1,800 lineal feet of shelf angles were repaired using the system at a 3.5- x 3.5-

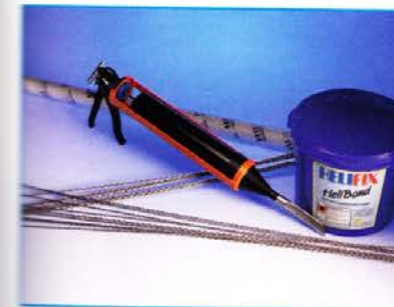
CRACK STITCH

About 300 lineal feet of HeliBar were used to repair vertical cracking in the brick masonry for numerous focus locations of the tobacco warehouse. Helifix's Crack Stitching system is a means of permanent crack repair designed for
